HA-1493

Chandler House
133 Thomas
Bel Air
Private

INVENTORY FORM FOR STATE HISTORIC SITES SURVEY

HISTORIC SITES SURVEY FIELD SHEET
Individual Structure Survey Form

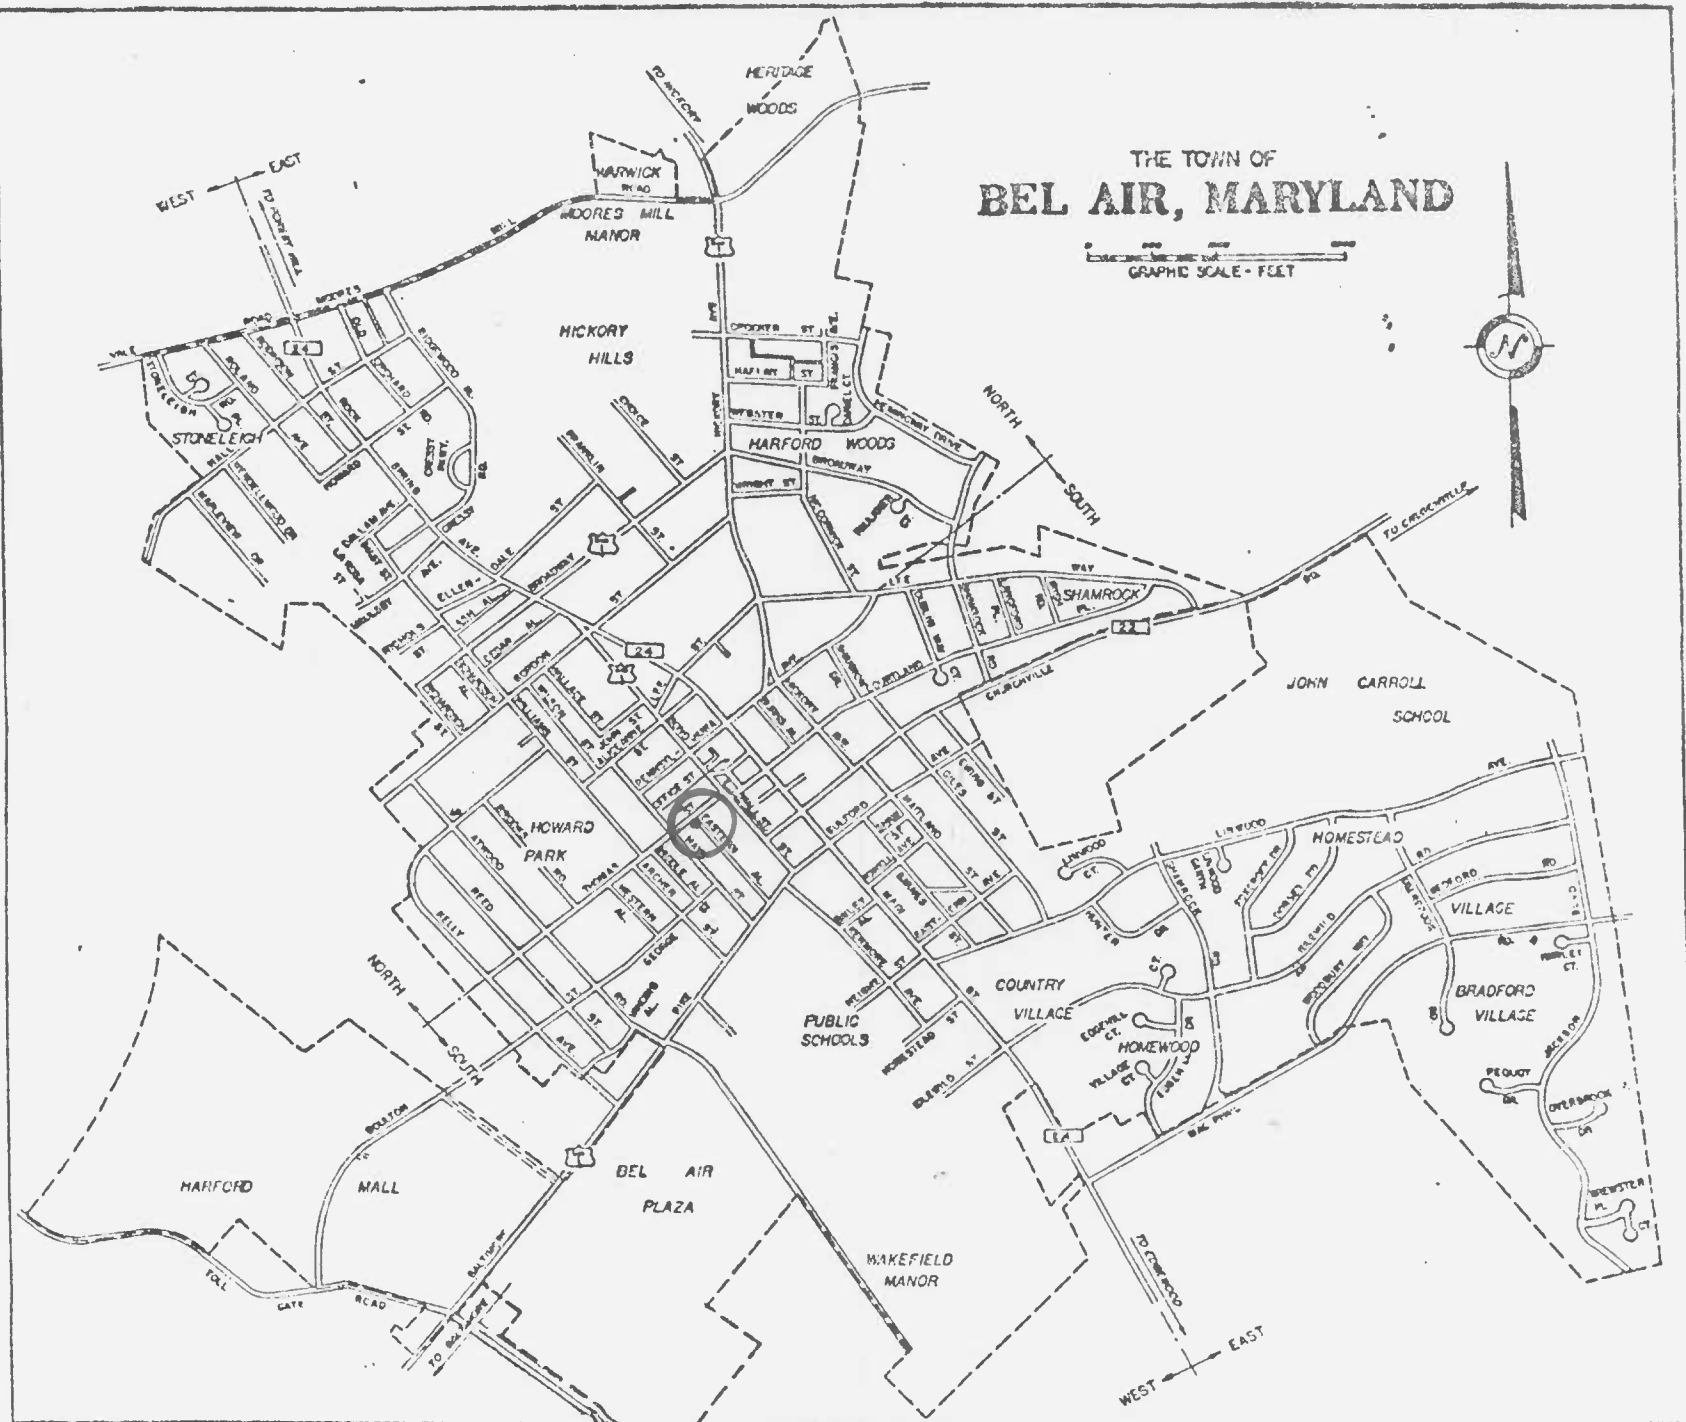
HA-1493 Chandler House, 133 Thomas St.
Bel Air

This is the best kept house in a row of two bay shotgun houses. It shows how attractive these modest homes can be, especially with roses climbing up a porch trellis.

This small, two-bay, two-story shot-gun house is at 133 Thomas Street in the Town of Bel Air, Harford County, Maryland. Its shiplap siding shines a sparkling white showing that this is an owner-occupied house. The windows are 6/6 double-hung sash set in plain, thin surrounds. The original half-glass door is topped by a two pane transom. The shed porch with a plain balustrade is carried on chamfered posts. The center chimney has a corbelled cap. The shed addition in back has been extended one bay to the west. This extension is covered in asphalt siding and has a single 4 pane casement in the front (north) elevation.

Red roses climb a trellis on the east side of the front porch, reminding us how attractive these humble homes can be when well kept.
